BARONESS

Technical Information Leaflet

TIL: 040

LM315GC

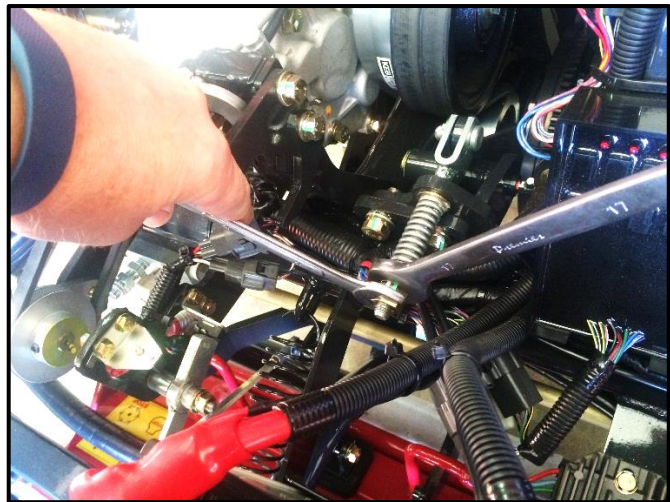
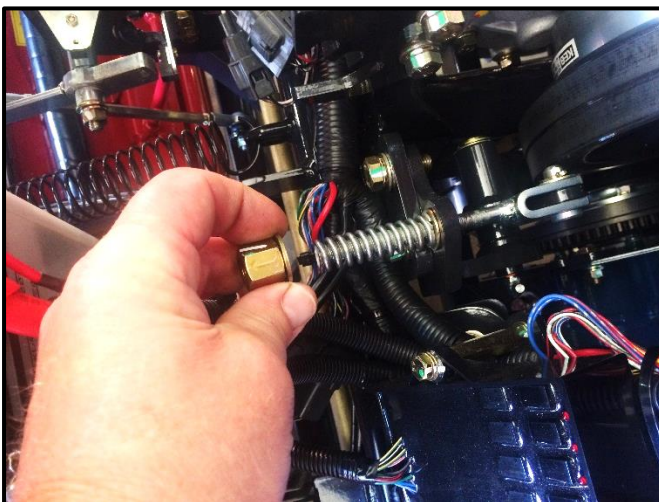
Using 2 x 17mm spanners, undo the locking nut (outer nut) on the threaded belt tensioning shaft as shown.

Remove the locking nut from the threaded tension adjuster rod.

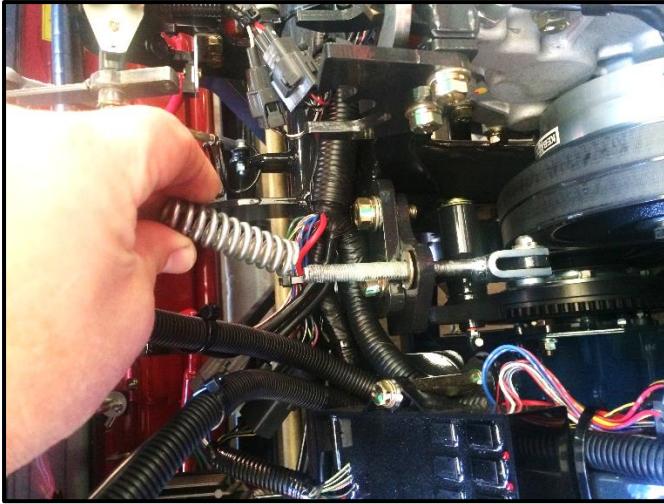
Remove the spring tensioning nut from the threaded tension adjuster rod.

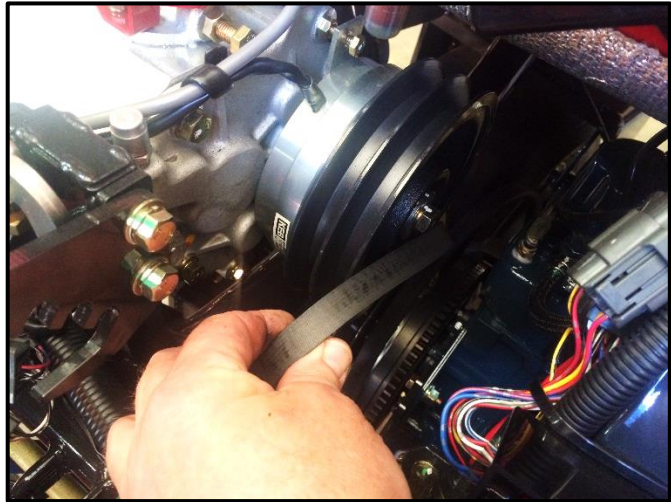
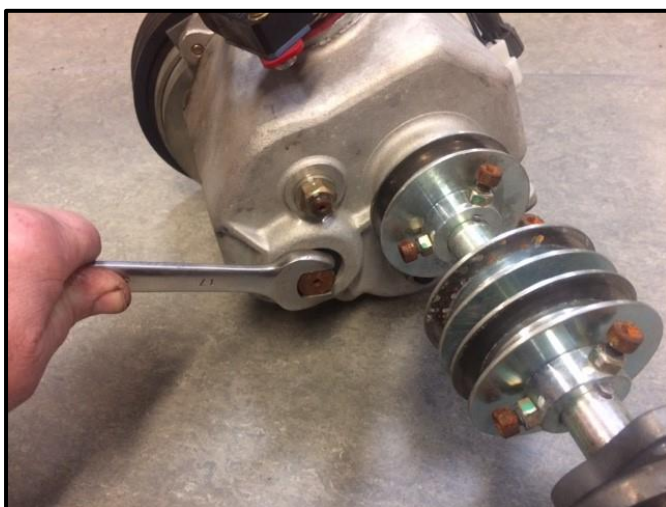
Remove the tensioning spring and its associated washers from the threaded adjuster rod.

With the belt tension now loose, remove the two drive belts from the top pulley, leaving them on the bottom pulley out of the way.

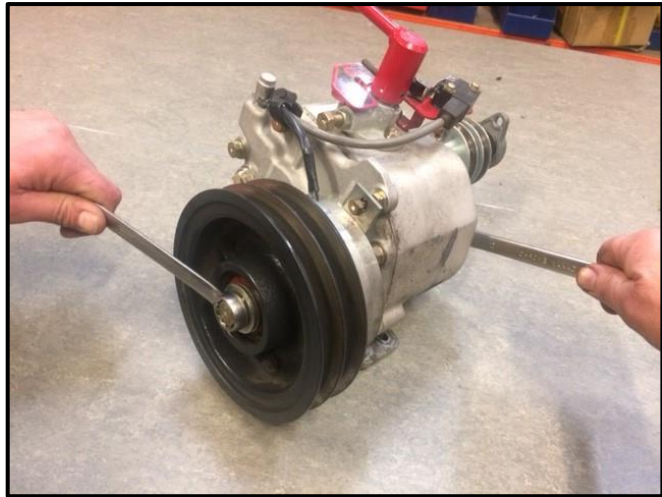
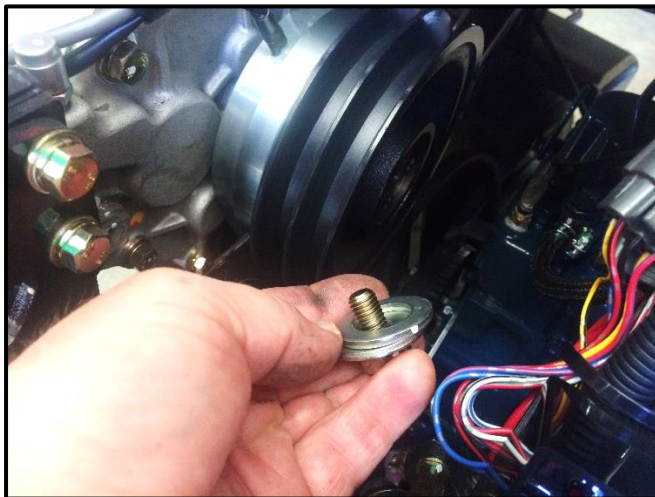
Locate the pulley shaft stub on the opposite side of the gearbox to the clutch.

This has 2 flats on it which can be held with a 17mm spanner to stop the shaft from rotating.

Whilst using a 17mm spanner to stop the gearbox shaft from rotating, undo the pulley bolt using another 17mm spanner as shown.

Note: Gearbox shown removed to make it easier to show in these instructions but this is not necessary as the task can be completed with it in situ.

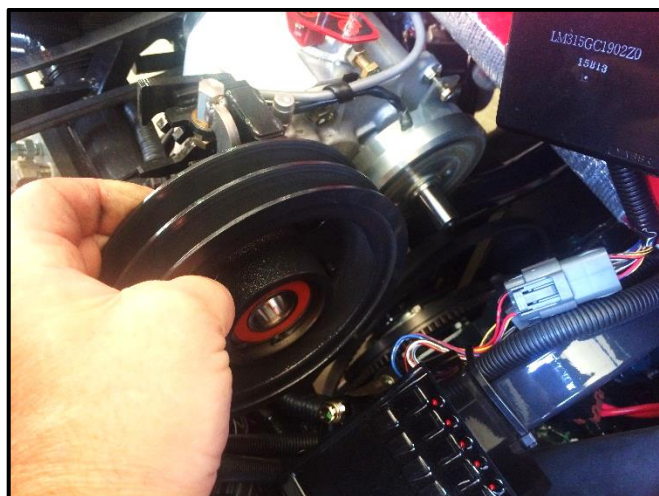
Remove the retaining bolt and associated washers.

Note: Be aware that there is also a larger diameter spacer washer over the gearbox shaft that also needs to be removed.

Remove the pulley assembly from the gearbox shaft as shown.

Note: If the clutch has not been adjusted in a while, the pulley bearings can stick on the shaft. If this is the case then you will need to use a puller to remove the pulley assembly.

Never be tempted to use a lever or hammer to remove the pulley as this could break the gearbox shaft.

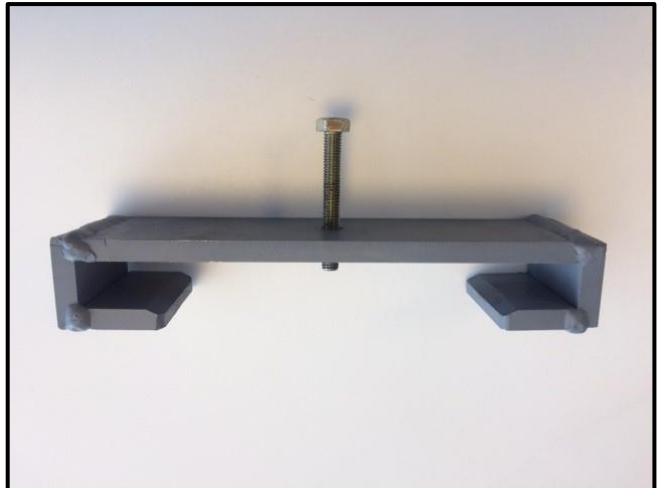
If you do not have a suitable puller then it is quite easy to make one as shown.

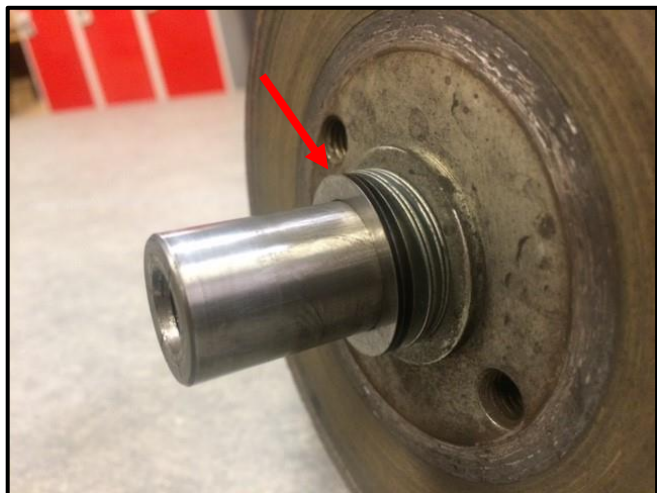
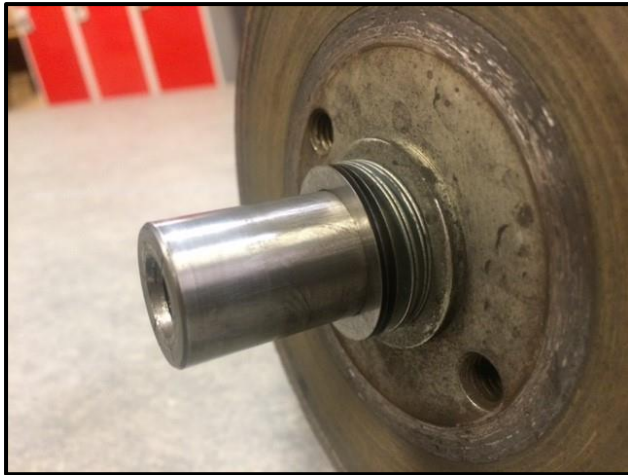
Once the drive pulley is removed you will see the clutch pressure plate.

This will most probably have a step worn on it. This is normal and nothing to worry about, but this wear step is the reason why we cannot measure the gap between the 2 clutch surfaces using a feeler gauge.

With the drive pulley removed you will see a series of shims fitted over the gearbox shaft as shown. These are what is used to adjust the clutch.

Removing shims will close the gap, adding shims will increase the gap.

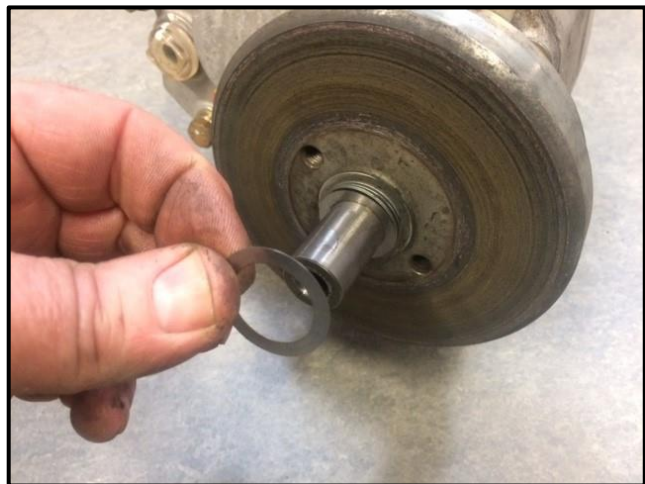
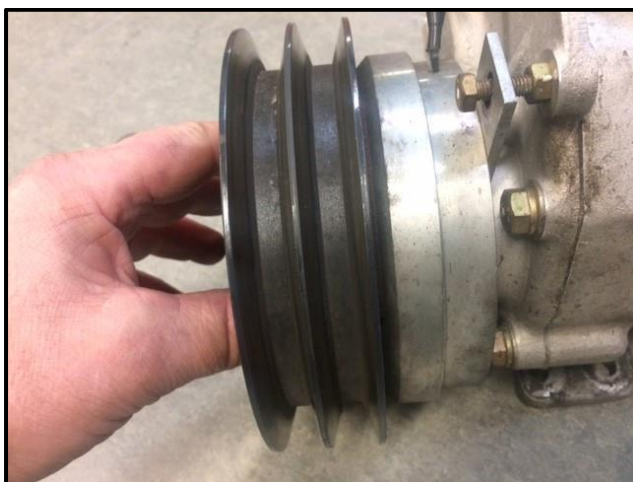
Before adjusting the clutch, clean the clutch shaft using some fine abrasive paper.

Also clean the surface of the bearings inside the drive pulley using some fine abrasive paper.

Apply a very small smear of grease to both surfaces. Do not apply too much as this must not get onto the clutch surface.

Once the clutch shaft has been cleaned you can now proceed to adjusting the clutch:

Remove one thin shim from the clutch shaft.

Then replace the pulley assembly.

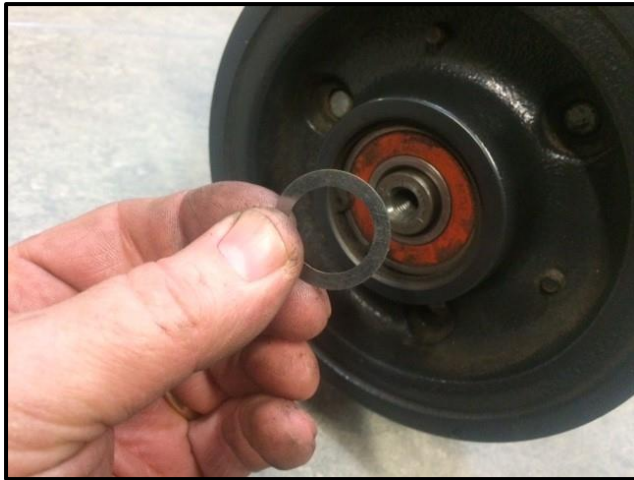
Rotate the pulley by hand.

If it rotates freely you will need to remove the pulley and then remove another thin shim. Keep repeating this process until the pulley starts to bind when it is rotated by hand.

When it starts to bind, add one thin shim. This should make the pulley spin freely again with minimal gap, which is the correct adjustment that we are looking for.

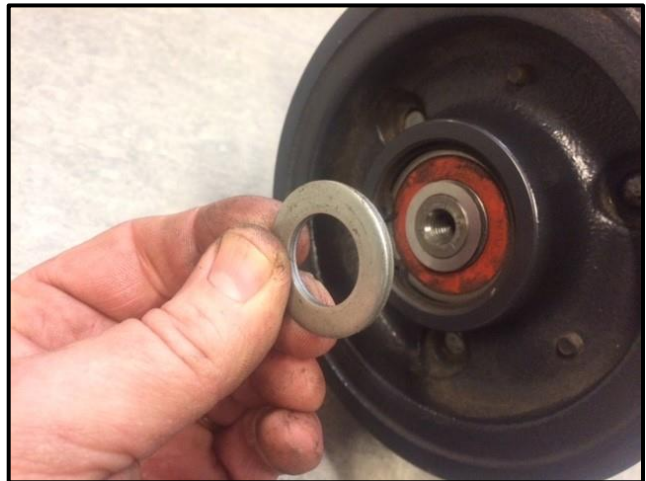
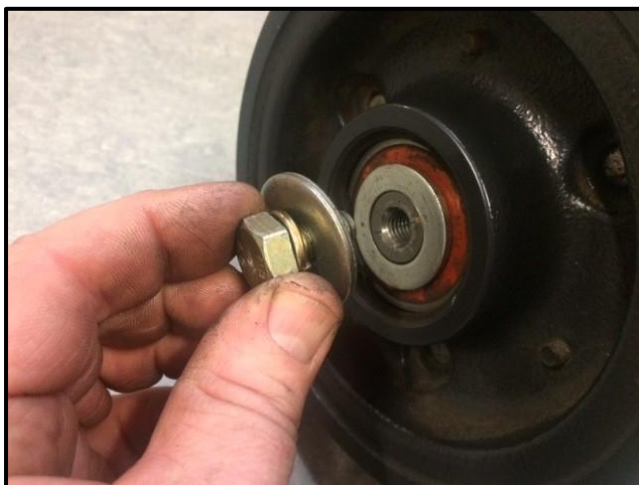
Store all removed shims on the outside of the drive pulley on the clutch shaft for future use.

It is very important that this is done because this is needed to complete the clutch adjustment process as it moves the pulley along the gearbox shaft and closes the gap between the clutch surfaces.

Fit the large spacer washer on the outside of the drive pulley on the clutch shaft.

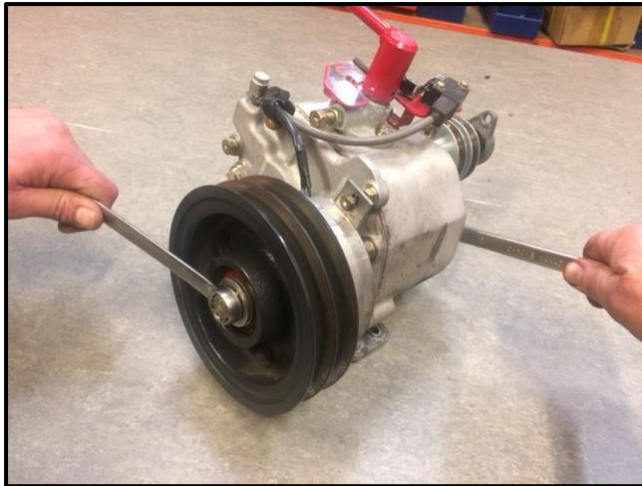
Refit the pulley retaining screw and washers to the clutch shaft as shown.

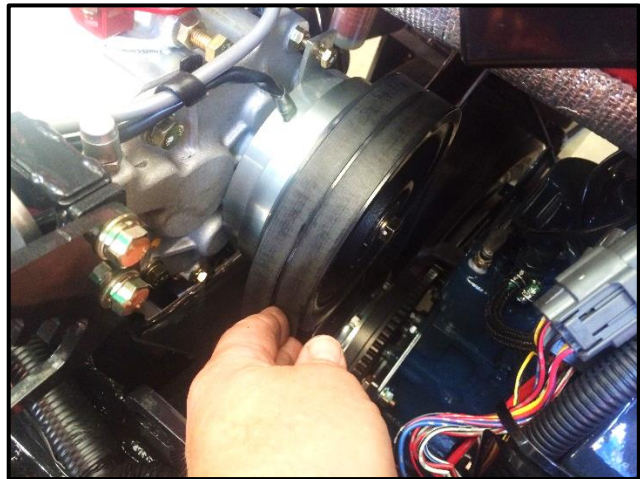
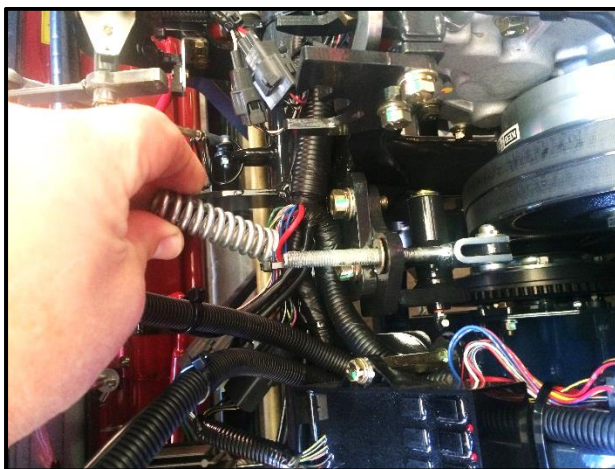
Holding the back end of the clutch shaft with a 17mm spanner, tighten the pulley bolt using another 17mm spanner.

Refit both drive belts onto the top and bottom pulleys.

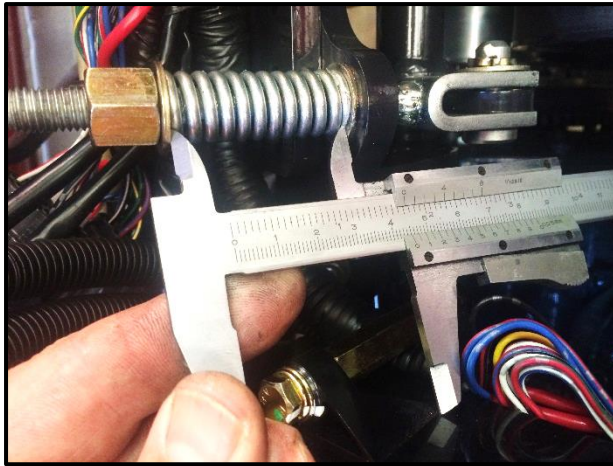
Reassemble the tension spring mechanism in the following order:

Washer

Spring

Adjuster Nut

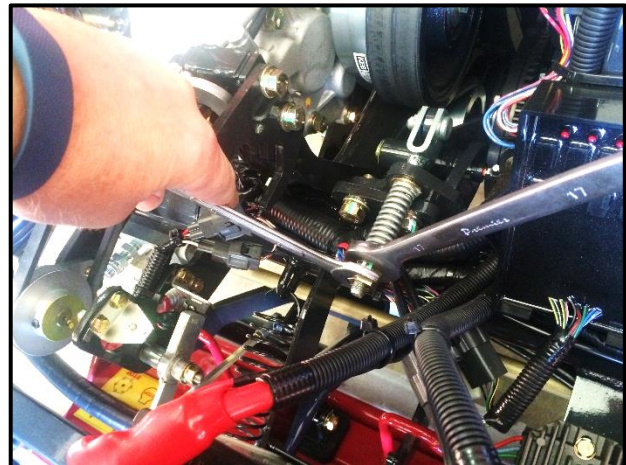
Tighten the adjusting nut until the tension spring reaches a length of 45mm.

Refit the tension adjuster locking nut and lock it to the adjuster nut using 2 x 17mm spanners.

Run the machine and check that the idler tension pulley runs square and central to the drive belts.

Adjust if necessary and retest.
